Read Avenue Outfalls Repair Project Project Review, Update and Recommendations

November 8, 2023

READ AVENUE
 CONSTRUCTION PLAN

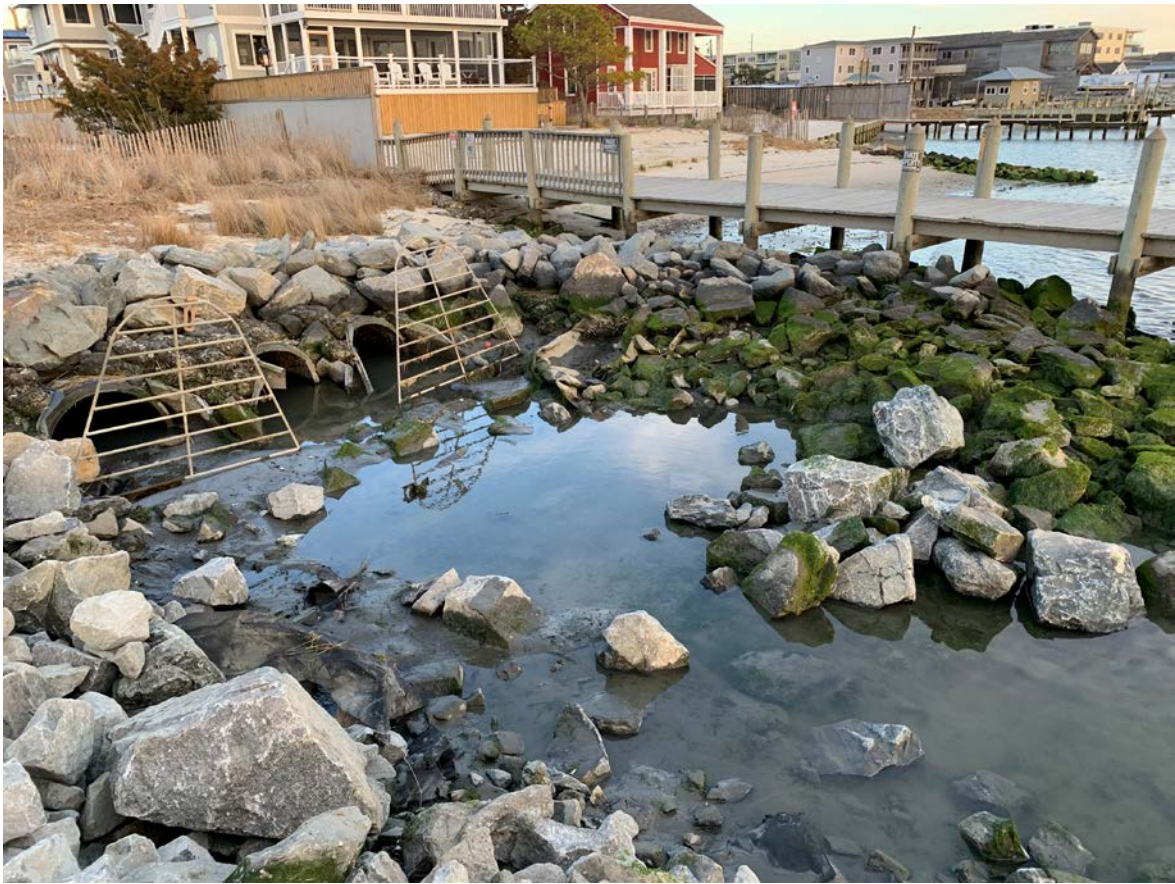
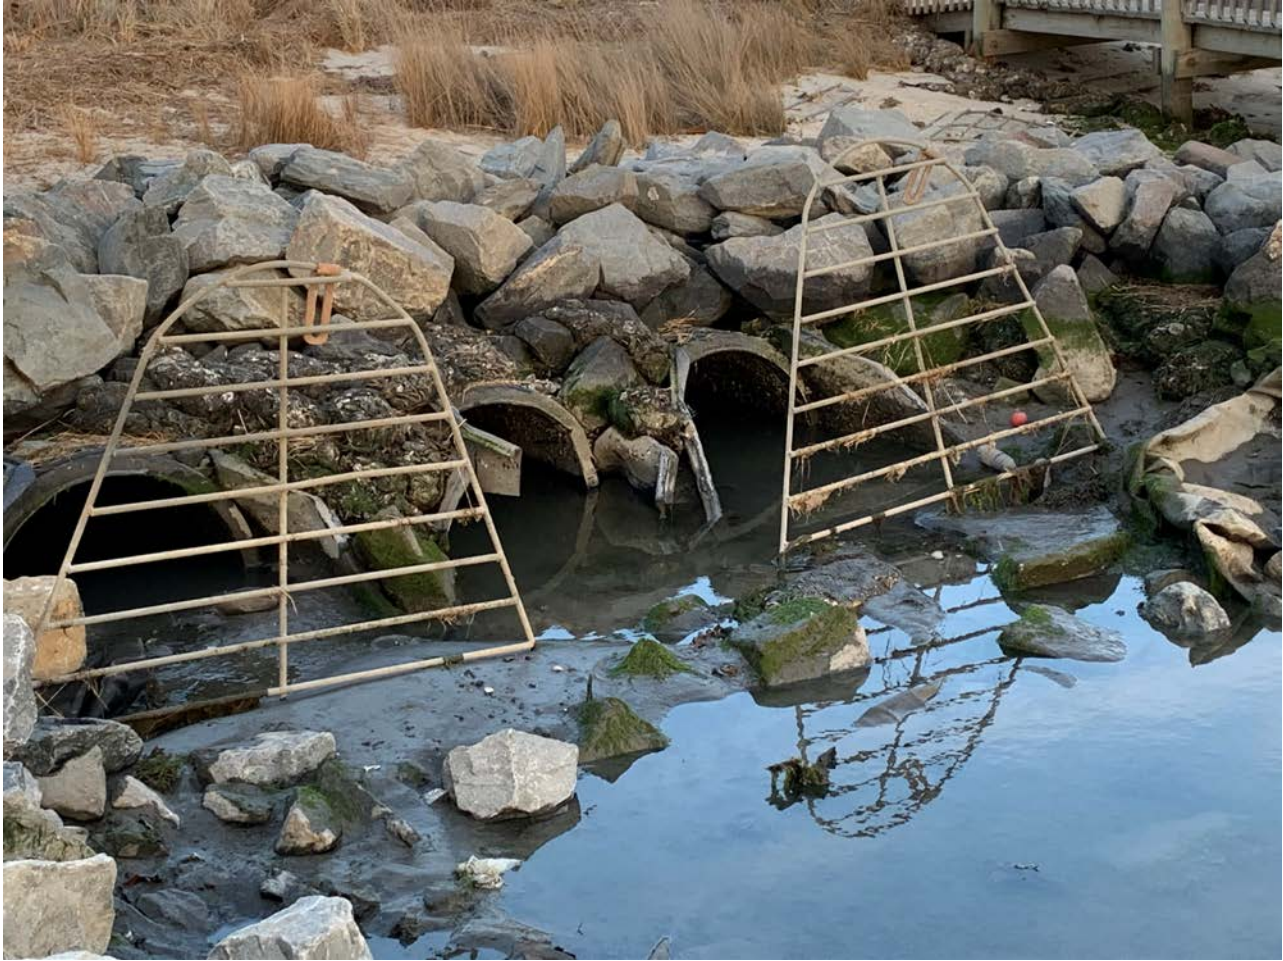
The red shows removal to help rebuild the canoe path. The green shows the riprap repair.

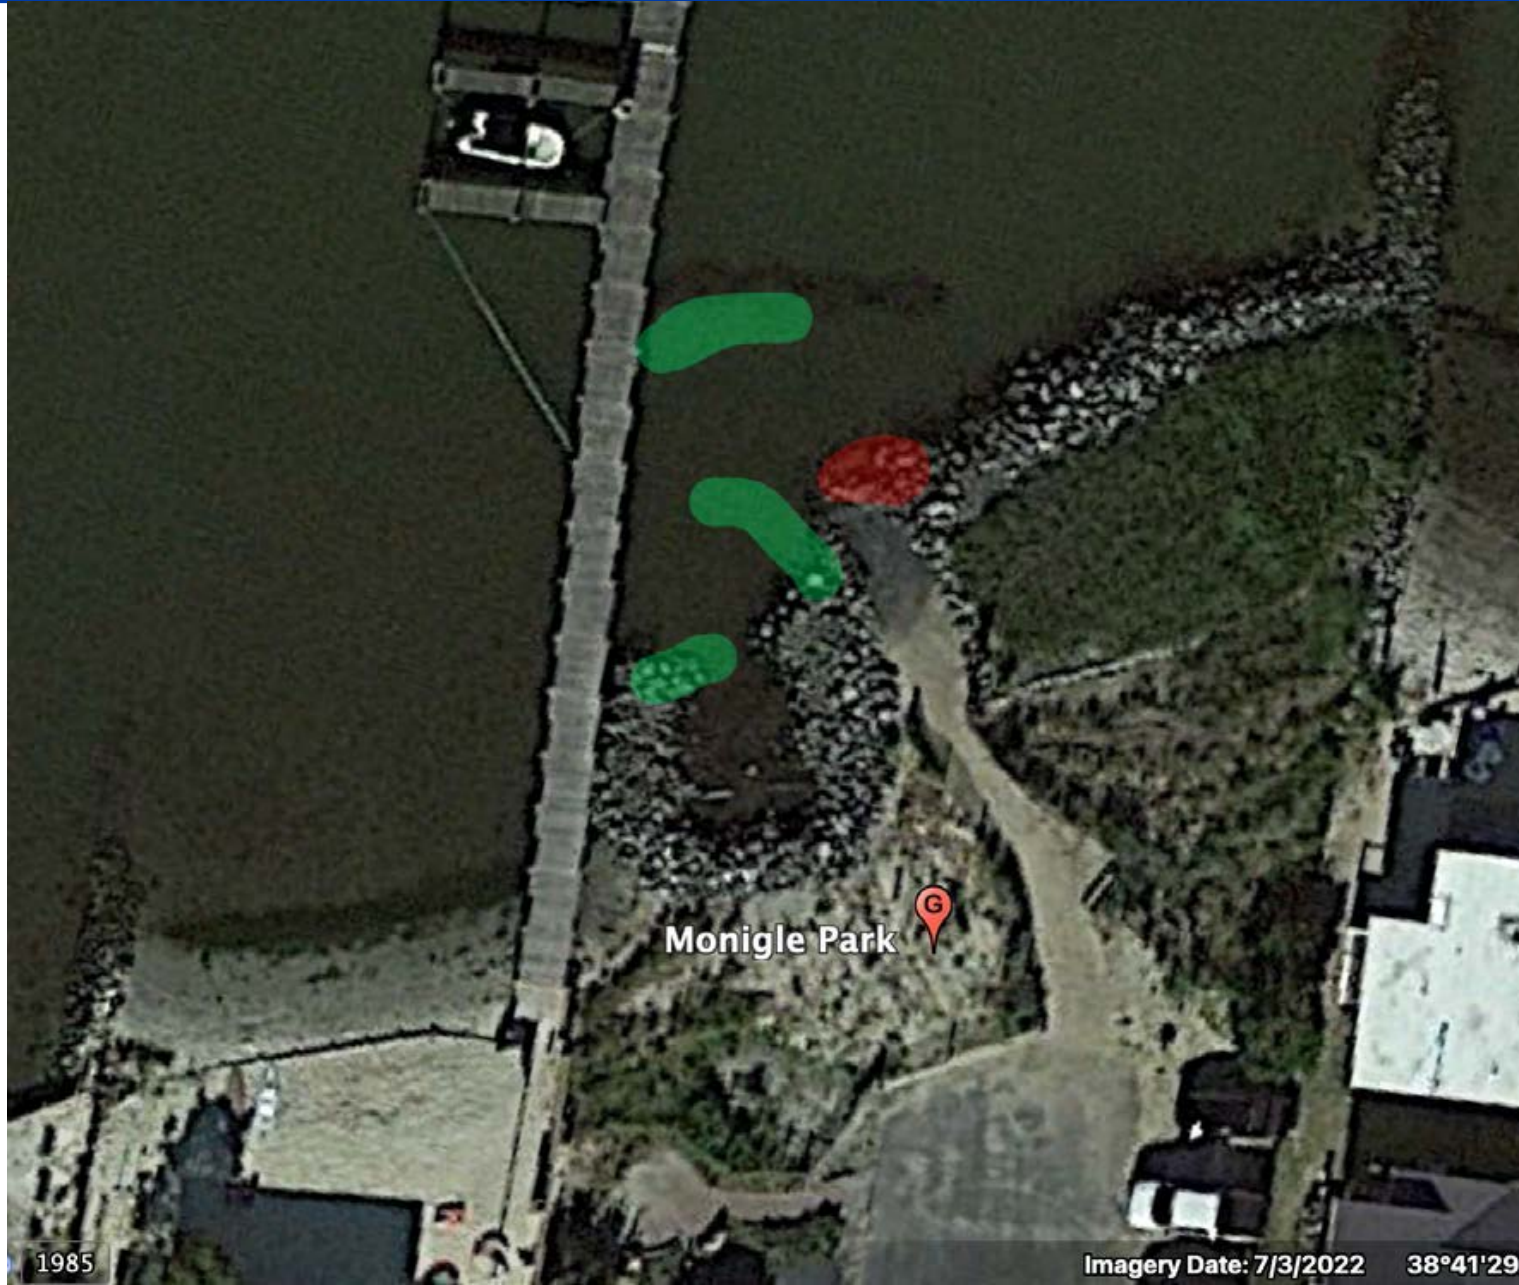
The red shows removal to help rebuild the canoe path. The green shows the riprap repair.
