Crosswalks and Red Flashers

Delaware Department
of Transportation

HAWK Pedestrian Signal Compliance Review

May 2020

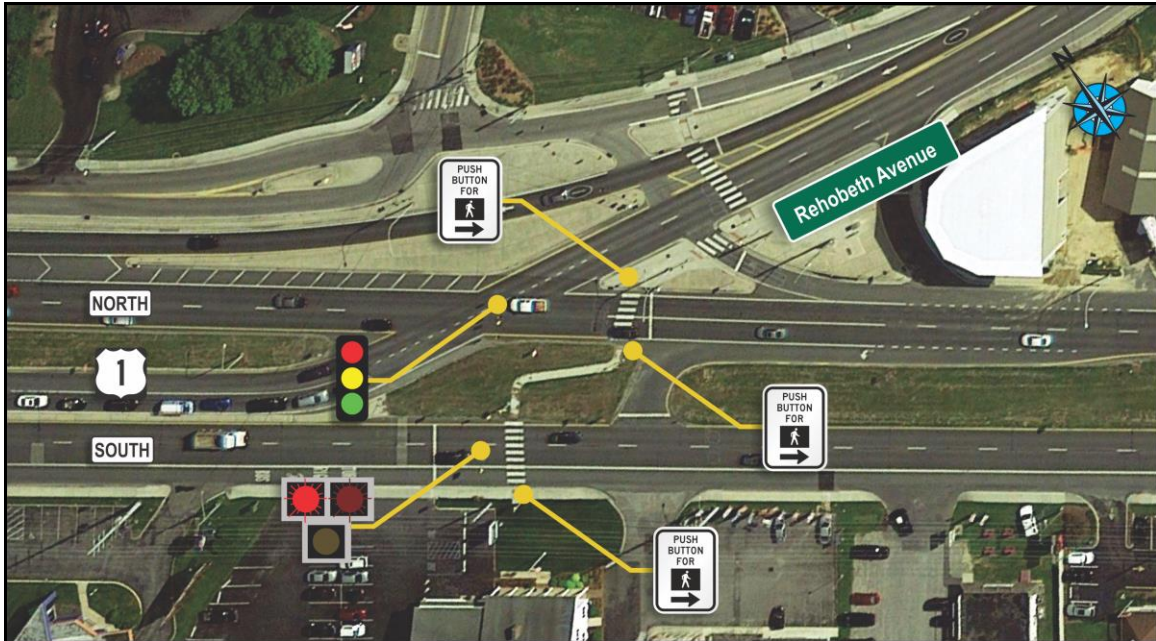
Figure 4: SR 1 and Rehoboth Avenue HAWK Signal

- **SR 1 at Rehoboth Avenue; Rehoboth Beach, DE:** Recent observations at the HAWK signal showed a decrease in the level of motorists' compliance, from a high of 87% in 2016 down to 59% in 2019. Recent observations revealed that pedestrians and bicyclists frequently activate the HAWK signal, but cross before the HAWK signal activates. As a result, many of the non-complying vehicles were observed when no pedestrians or bicyclists were present. This may be a factor in the increase of vehicles disregarding the HAWK signal between 2016 and 2019. Crash data showed that total crashes have increased by 27% since the installation of the HAWK signal, which included an increase in pedestrian crashes (0 to 1) and bicycle crashes (0 to 3), though no crashes were directly attributable to the new signal.

Based on these observations and poor motor vehicle and pedestrian compliance, particularly at the HAWK signals on SR 1 at Holland Glade Road and Rehoboth Avenue, **it is recommended that HAWK signals should not be installed on multilane roadways with more than two (2) lanes in each direction unless the signals are timed to permit a single-stage pedestrian crossing. Similarly, it is recommended that HAWK signals should not be installed at locations with wide medians requiring a two-stage pedestrian crossing.**

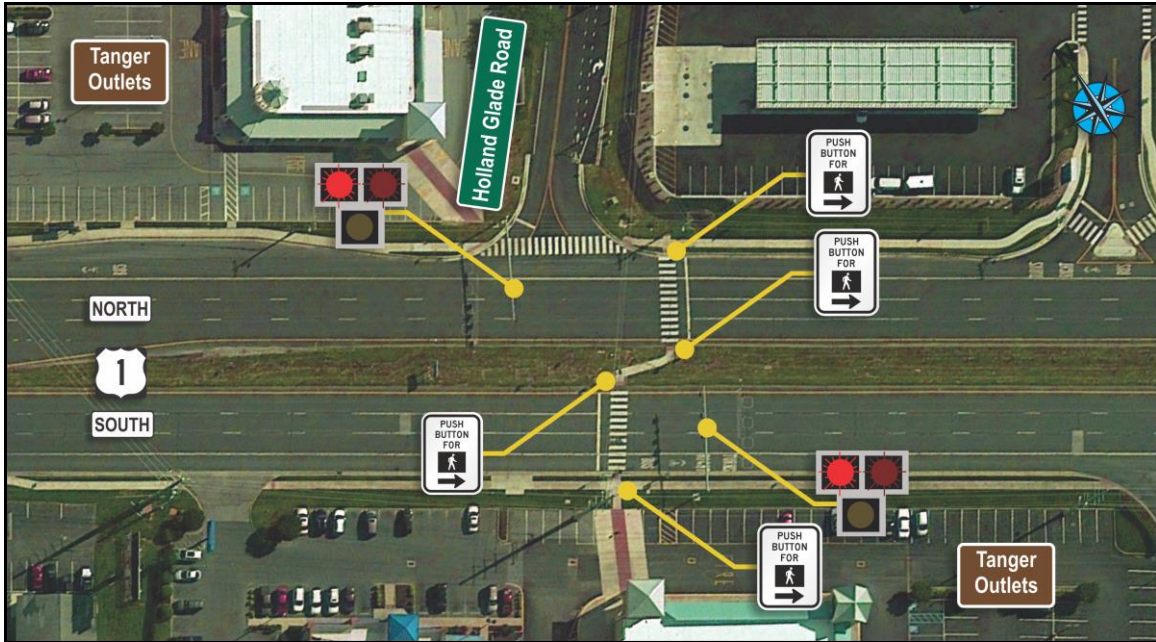
Figure 5: SR 1 and Holland Glade Road HAWK Signal

RK&K observed the percentage of motorists complying with the HAWK signal. Based on the results from the observations, the compliance for motorist stopping for the HAWK signal has decreased (worsened) from 97% in 2016 to 72% in 2019. In 2016, only 3% of motorists disregarded the traffic signal (3%+0%+0% in **Table 11**). However, in 2019 approximately 28% of motorists (7%+2%+19% in **Table 11**) disregarded the traffic signal, with the majority of those motorists failing to stop during the clearance interval when the signal is flashing red. As noted previously, several observations were made when pedestrians pressed the pushbutton but crossed the street without waiting for a WALK indication. This resulted in some of the 28% of motorists disregarding the HAWK signal when no pedestrians or bicyclists were present. In addition, when the HAWK signal activates and begins to flash yellow, motorists were observed speeding up to “beat the light.”

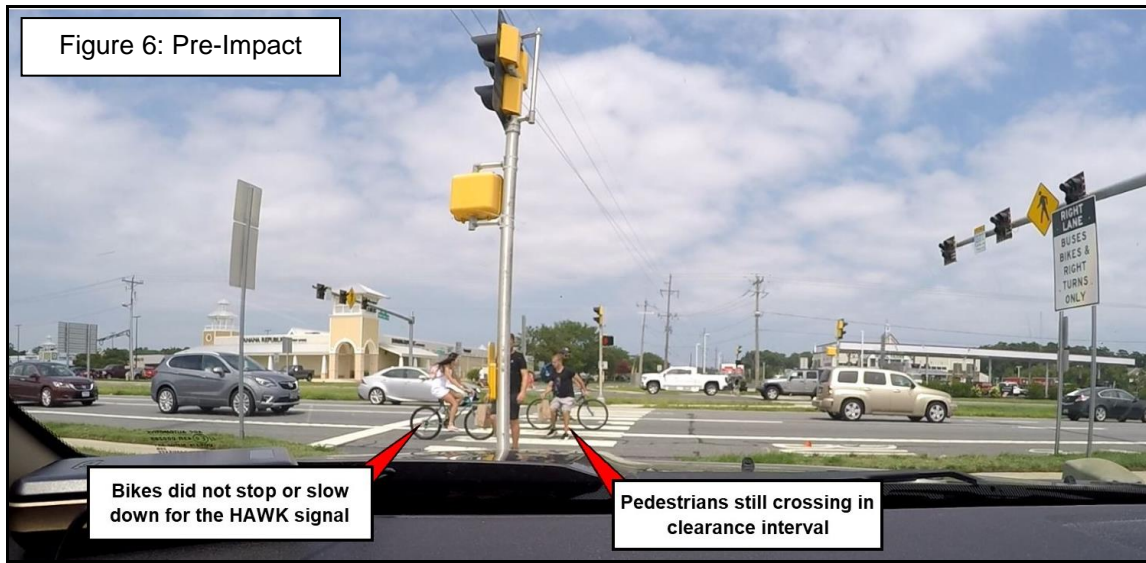
The field observations at SR 1 and Holland Glade Road also revealed conflicts between pedestrians and bicyclists. Bicyclists frequently ignore the HAWK signal and do not stop or slow down for pedestrians, which creates a potential conflict. An example of this is shown in **Figures 6 and 7** when a pedestrian in the crosswalk was struck by a bicyclist. During this incident, two (2) pedestrians were crossing the southbound lanes during the clearance interval. Two (2) bicyclists traveling southbound on SR 1 failed to stop or slow down for the HAWK signal or the pedestrians, which resulted in one of the bicyclists striking the pedestrian.

Figure 6: Bicyclists failed to stop for the SR 1 and Holland Glade Road HAWK Signal

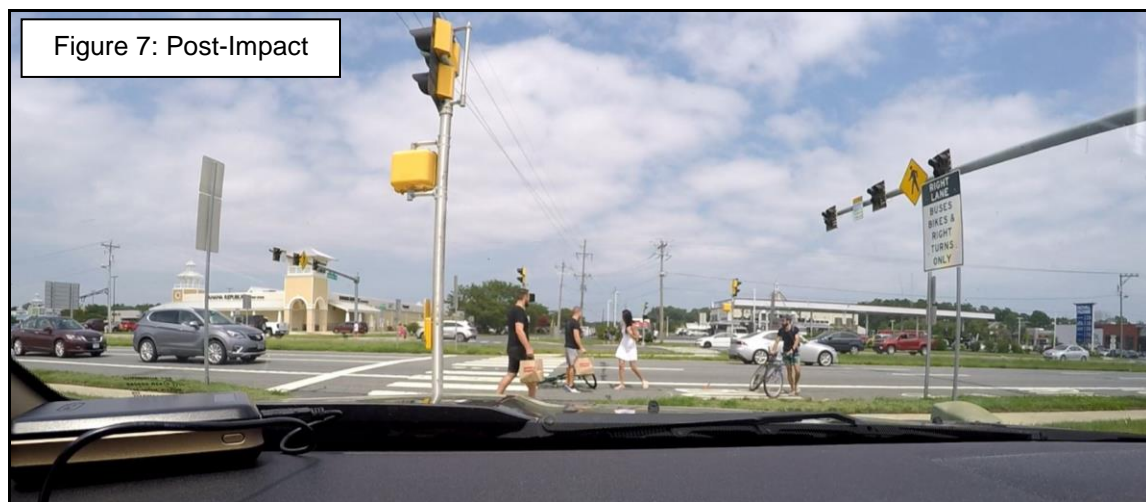
Figure 7: The bicyclist struck the pedestrian

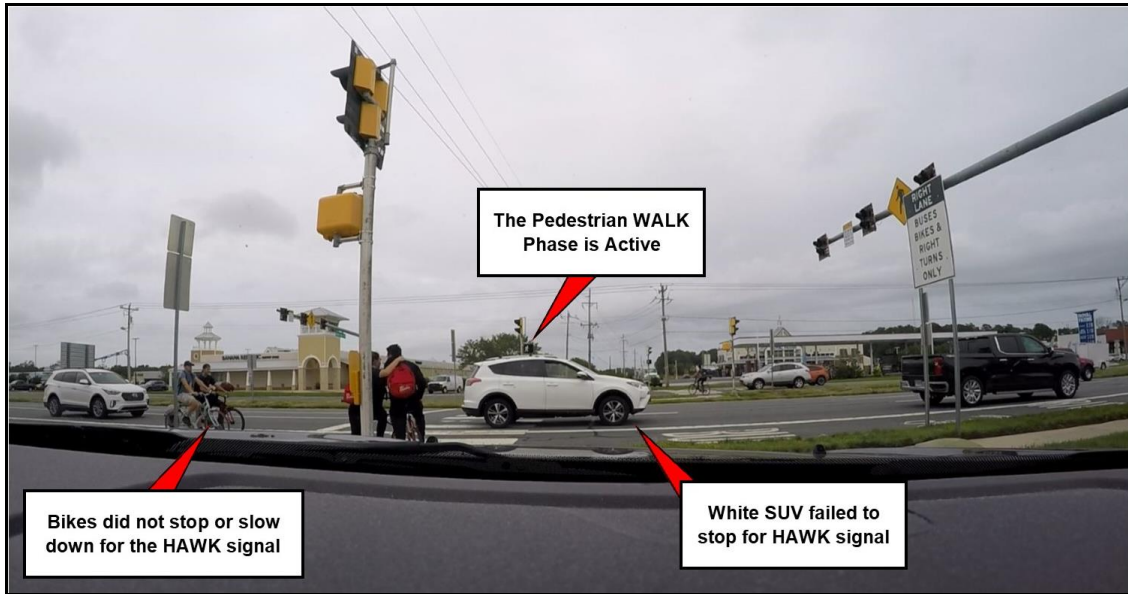
Figure 8 shows the importance of checking for oncoming traffic even if the pedestrians have the WALK phase. In this image, the pedestrians have the WALK phase, but the white SUV ran the red light and the bicycles did not slow down or stop for the HAWK signal.

Figure 8: Examples of conflicts at SR 1 and Holland Glade Road HAWK Signal

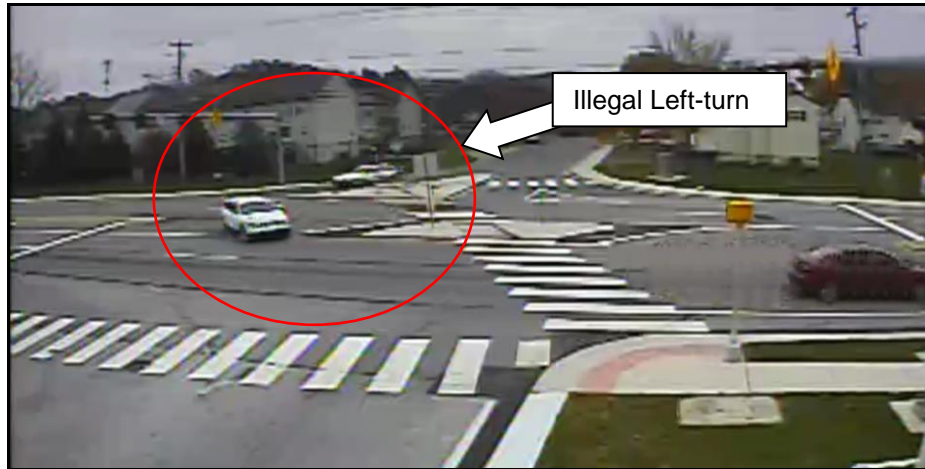
Field observations at this site revealed a safety concern associated with the installation of a HAWK signal at a four (4) leg intersection with channelized movements. Specifically, there are large channelizing islands on the north and south legs to prevent vehicles from turning left onto SR 273 from the minor street approaches. However, during the field observations, vehicles were observed using the gap in traffic created by the HAWK signal to illegally drive around the islands to turn left onto SR 273 (see **Figure 10**). This action by the motorists creates a safety hazard for pedestrians using the crosswalk during the WALK phase.

Figure 10: Vehicle turning left from Freedom Trail
