# CLIFF HOUSE BEACH PARKING

## Review of Shore Road

### February 2025

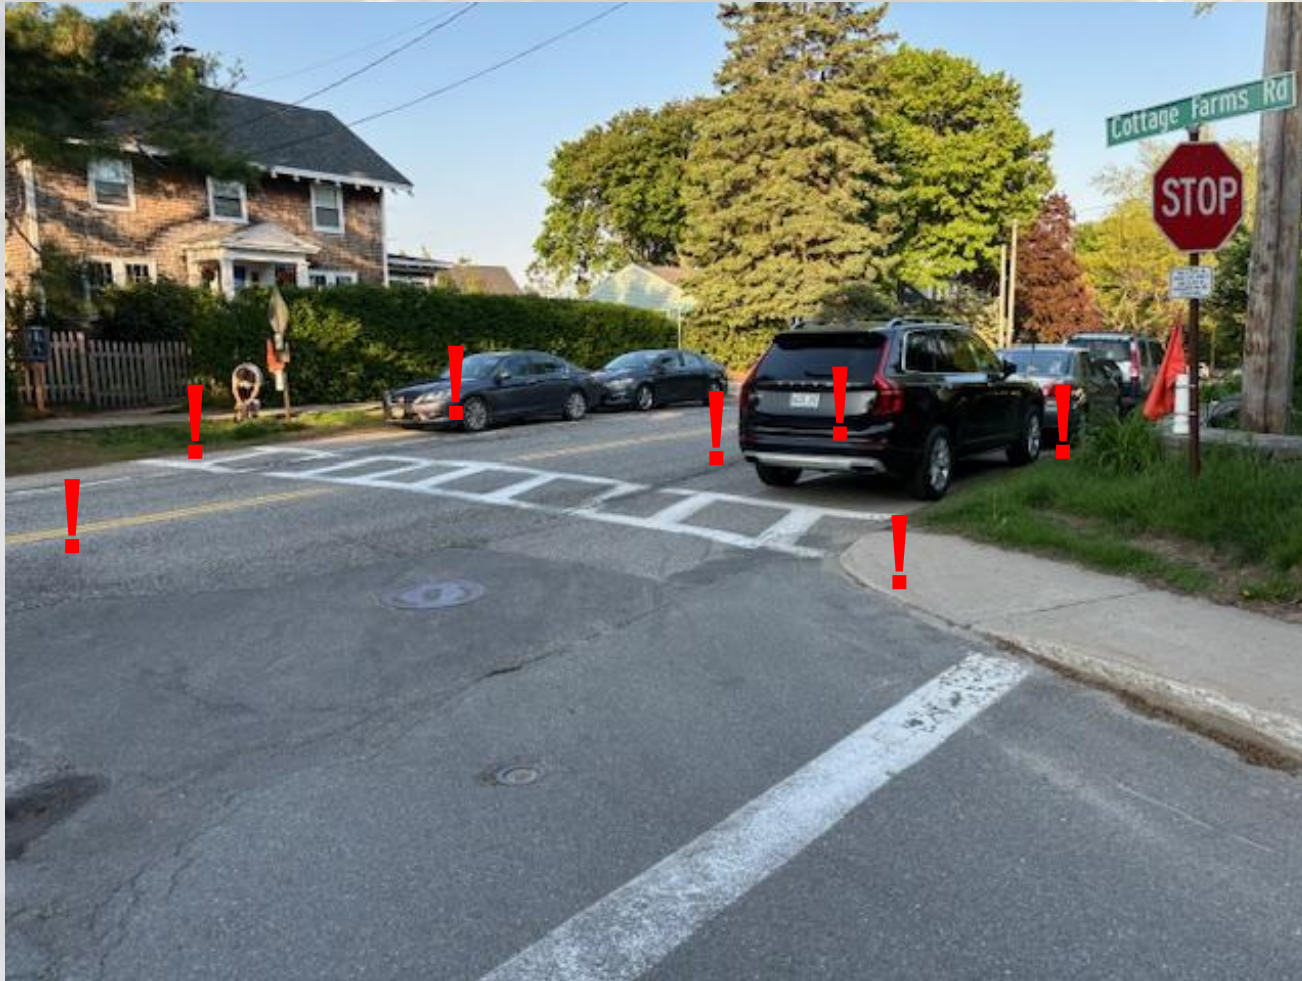
What is wrong in this picture?

- Parking in the crosswalk
- Parking within 25-feet of intersection
- Non-compliant crosswalk ramps
- No break in centerline at intersection
- Missing crosswalk signage
- No defined space for bicyclists
- No sight distance for pedestrians, bicyclists, and motorists

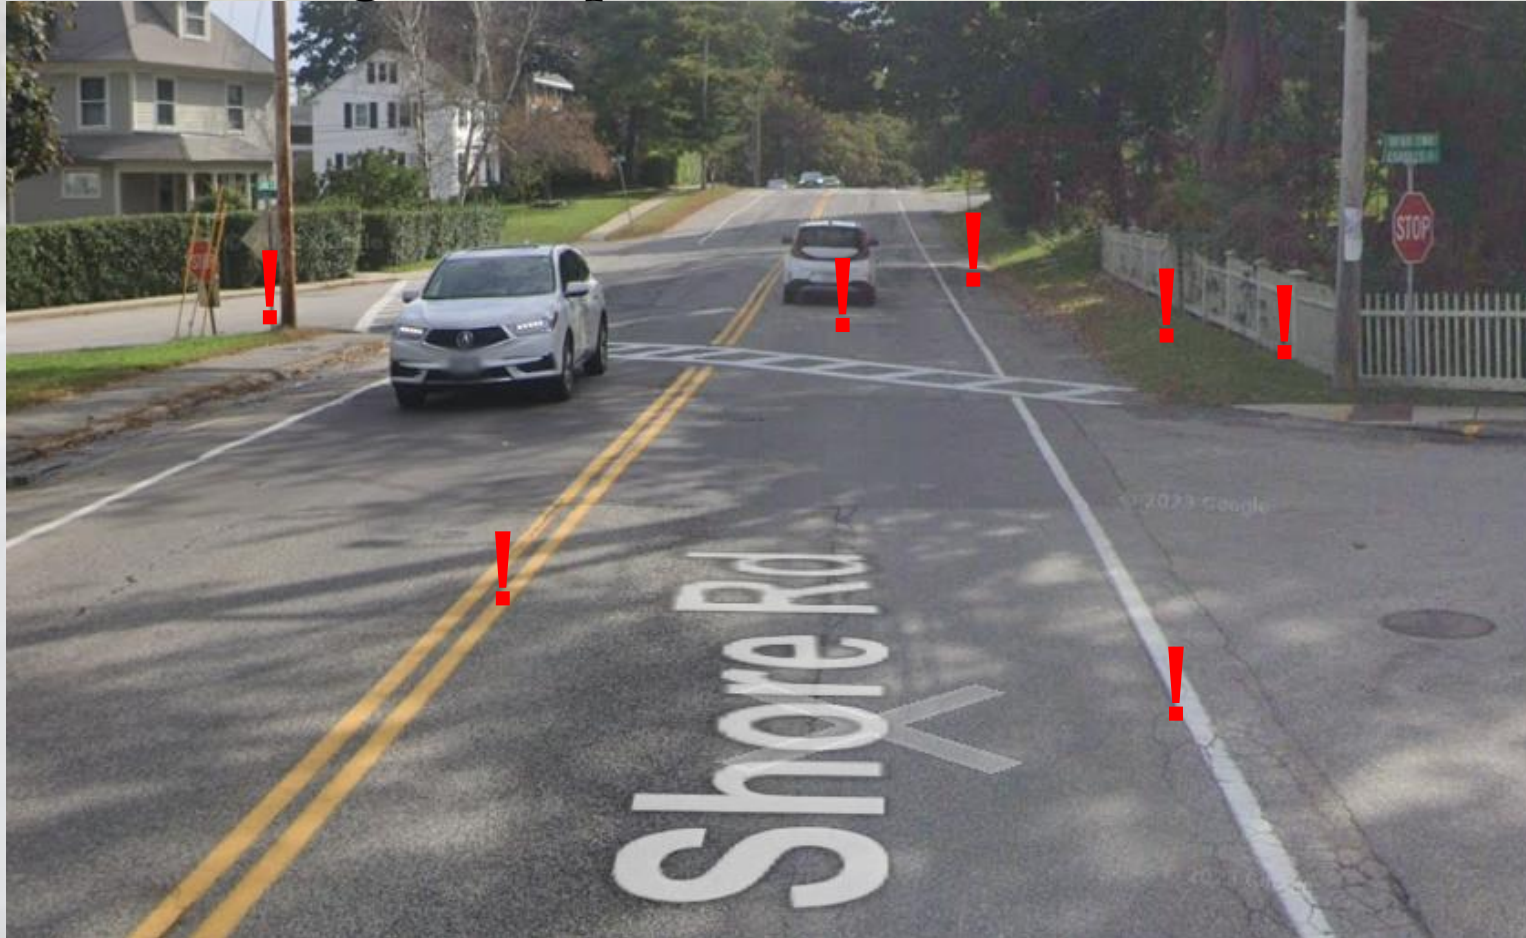
What is wrong in this picture?

- Non-compliant crosswalk ramps
- No break in centerline at intersection
- No break in edge line at intersection
- Missing parking (25' from intersection) signage
- Missing crosswalk signage
- Incorrect location and sign type for crosswalk
- Vehicle lane widths are wider than standardized lanes for 30MPH roads
- Undefined shoulder (is it parking or a bike lane?)

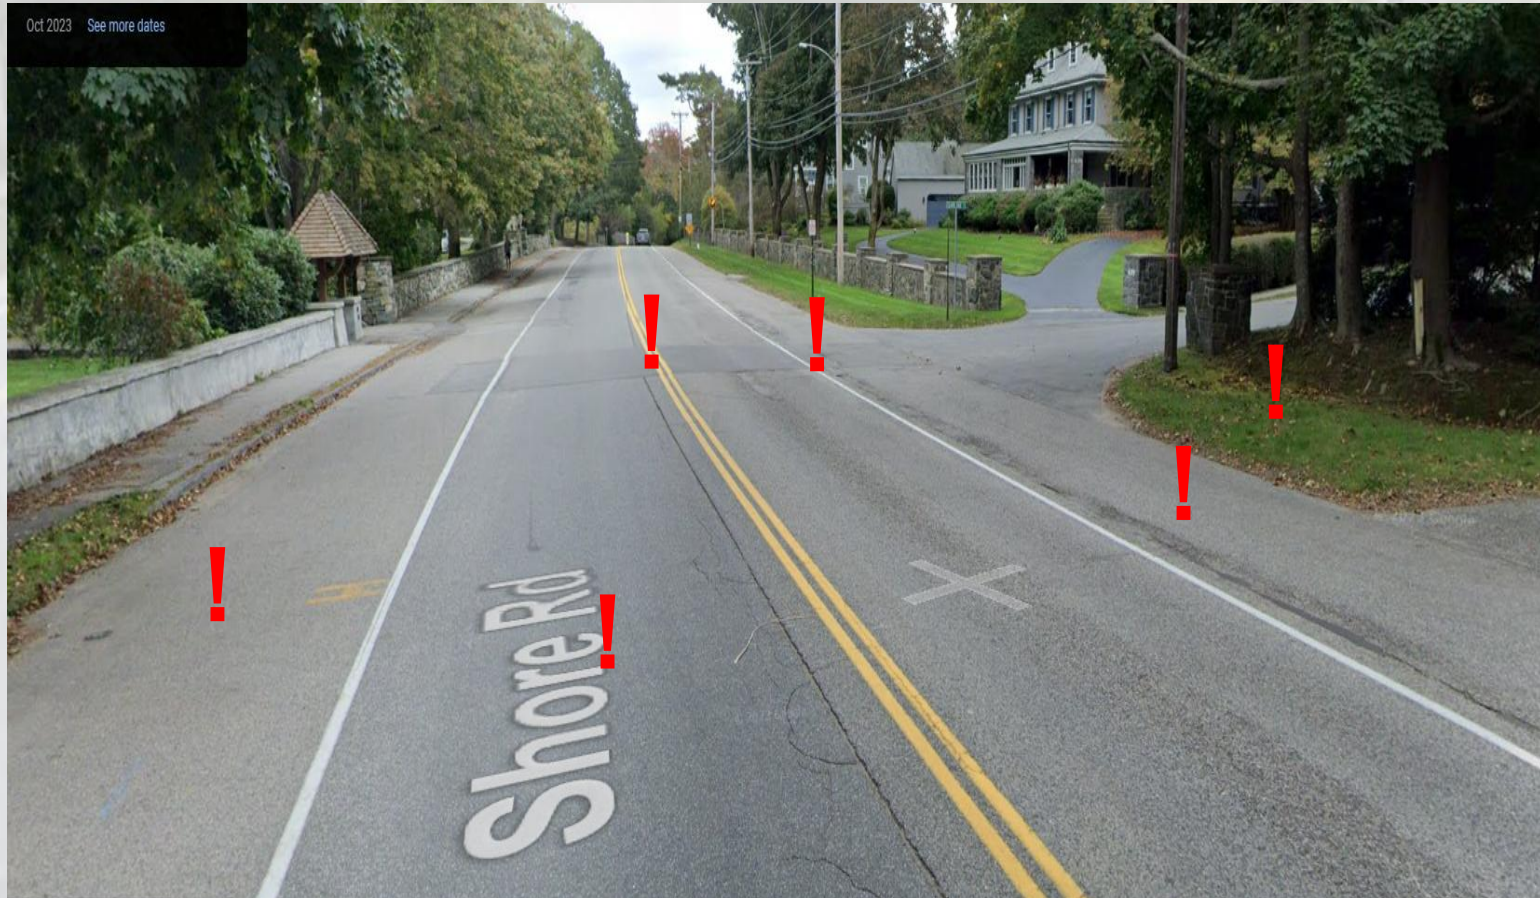
What is wrong in this picture?

- No break in centerline at intersection
- No break in edge line at intersection
- Missing parking (25'- intersection) signage
- Parking not restricted near driveway
- Parking not restricted in front of fire hydrant
- Lane widths vary from northbound/southbound sides

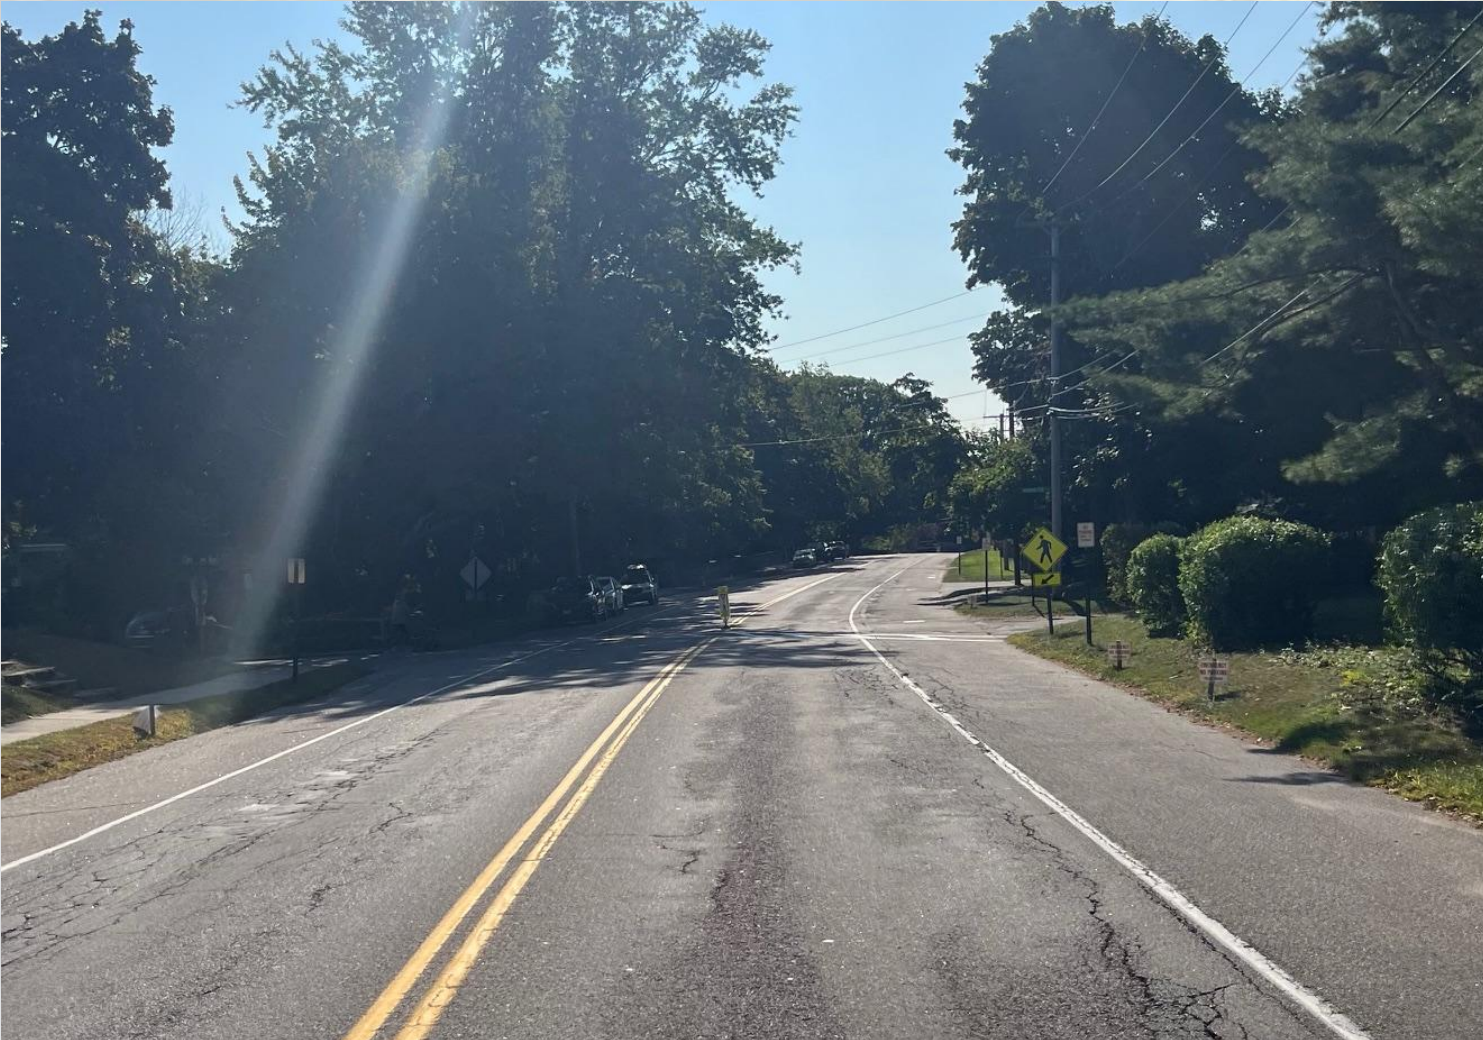
What has been done in the short term?

- Added Crosswalk signage
- Corrected crosswalk sign locations
- Corrected crosswalk sign types
- Added supplemental centerline crosswalk signage
- Installed no parking (25' from intersection) signage
- Temporary emergency no parking signage on curves and near driveways

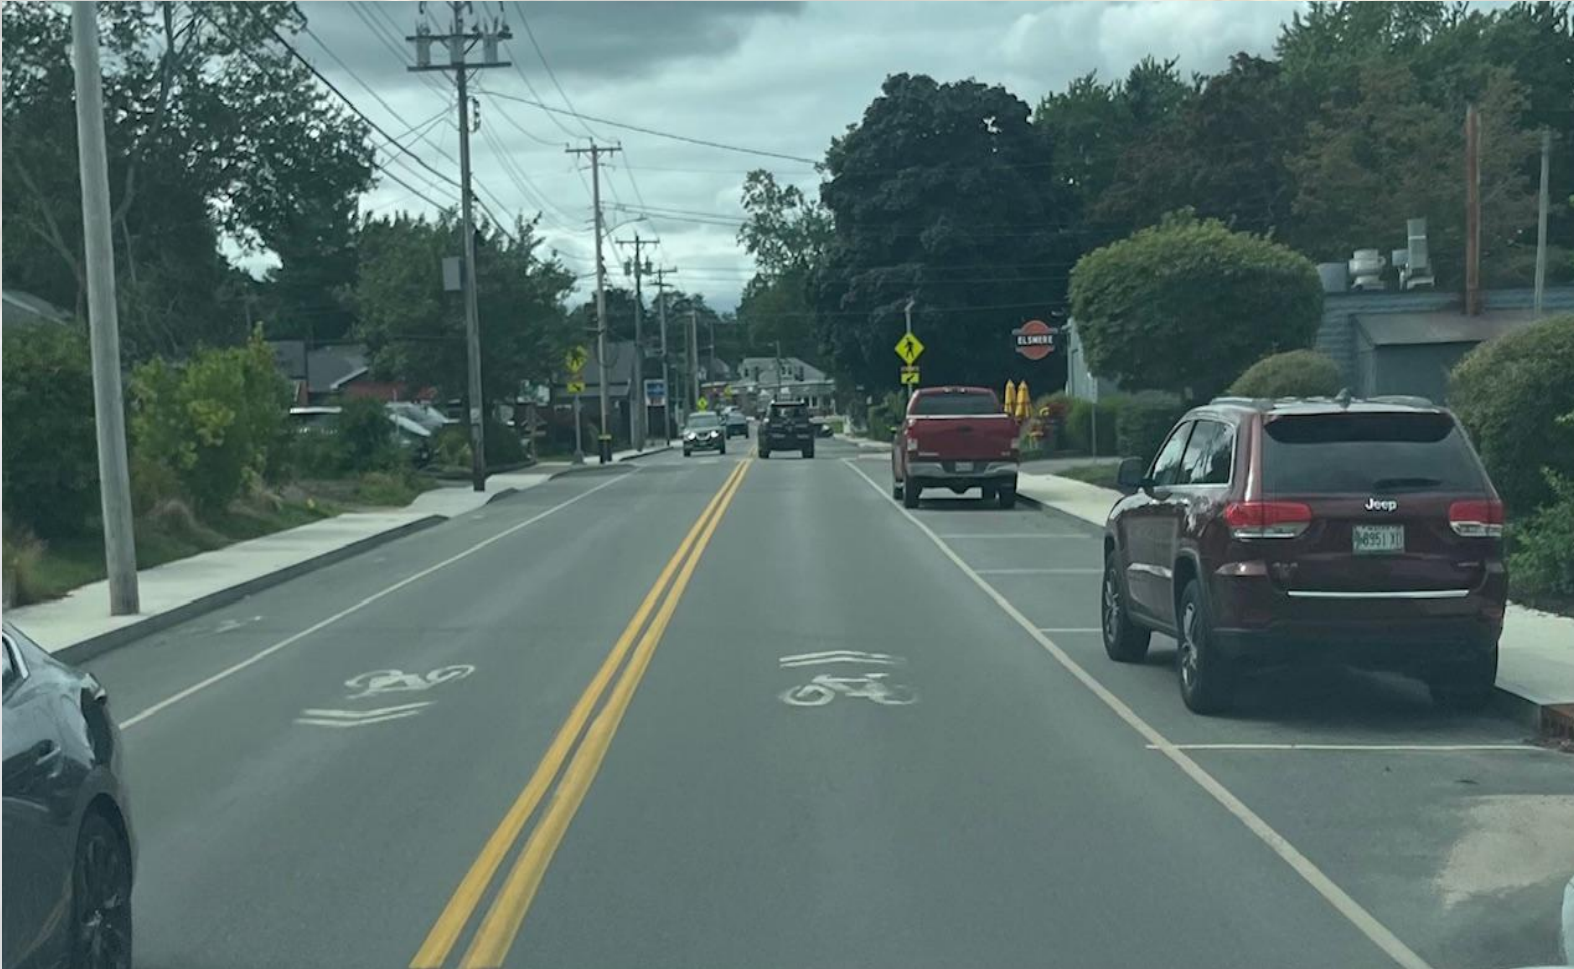
What can be done additionally in the short term?

- **Narrow the travel lanes**
- **Define the allowed parking areas**
- **Define the travel lanes as shared use lanes (bicyclists)**
- **Provide breaks in the striping at intersections**
- **Provide separation between parking and crosswalks**
- **Provide separation between parking and driveways**
- **Provide separation between parking and fire hydrants**
