GREENBELT INFRASTRUCTURE ASSESSMENT

TOWN OF CAPE ELIZABETH, MAINE

2020

FB ENVIRONMENTAL ASSOCIATES

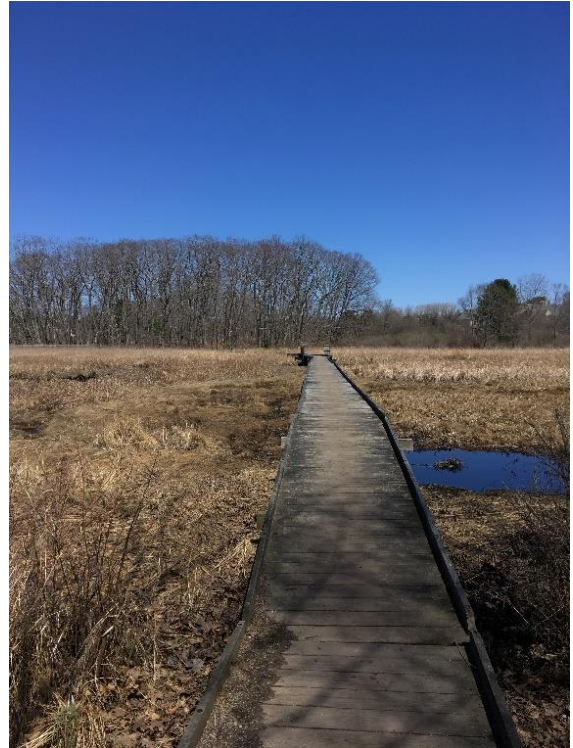
Boardwalk crossing the upper Spurwink marsh on the Town Center Trail.

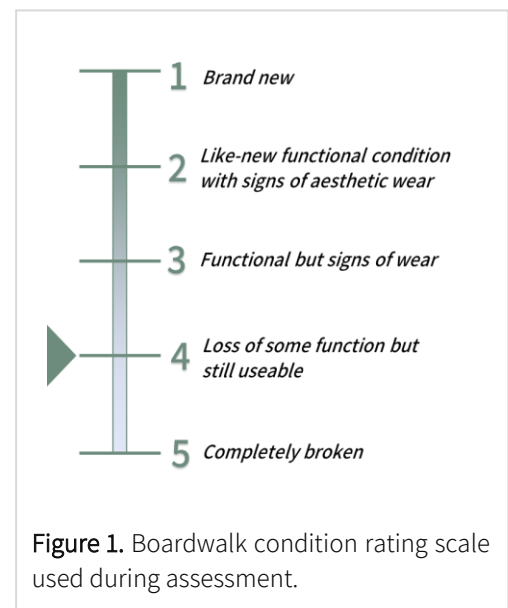
Figure 1. Boardwalk condition rating scale used during assessment.

Existing boardwalk sites were initially categorized according to how they were structurally compromised. Examples include missing boardwalk slats, rotting wood, instability, compromised landings, etc.. The severity of the impact was quantified by a condition rating that could be applied to each site (Figure 1). This one-to-five scale ranged from one or “Brand New” to five or “Completely Broken”. Creating a quantifiable scale to assess existing boardwalks will allow the Town to easily sort sites according to functionality. Boardwalks were then assessed for use level (light, moderate, or heavy traffic). This qualitative parameter was based on the field observer’s perceived use level and user traffic while on site, such as the frequency of bikers passing during the assessment or the severity of surrounding vegetation trampling. Physical parameters including length, width, maximum height from ground/water to boardwalk surface, and boardwalk slat gap width if parallel to travel, were measured and recorded. (The Conservation Committee has adopted a boardwalk standard width of 30 inches. All

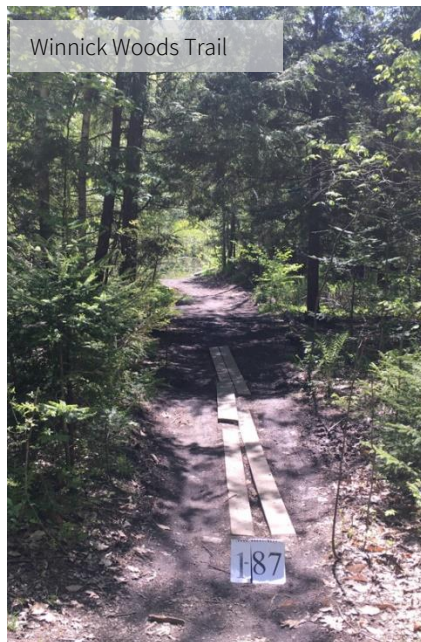
Photo 1. Boardwalk site with no proper foundation, rated at a 4 on the boardwalk condition scale due to loss of some function.

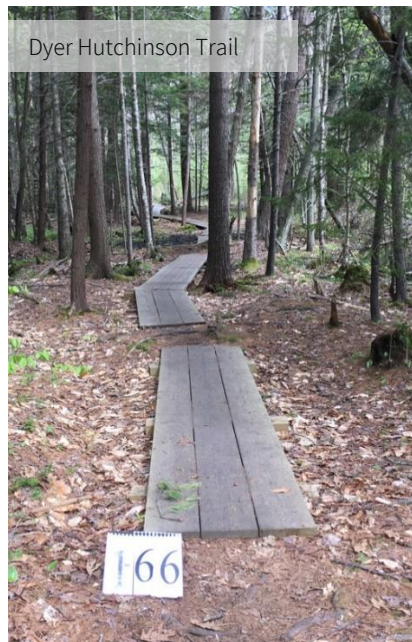
Photo 2. Boardwalk in excellent condition, rated at a 1 on the boardwalk condition scale.

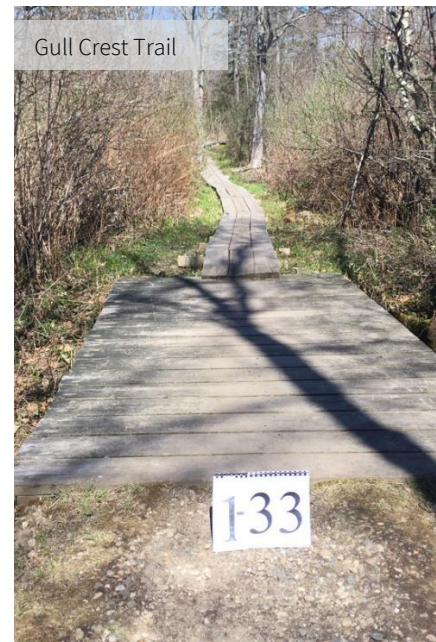
Photo 3. Adjacent boardwalks are logged as separate sites due to having different condition ratings.

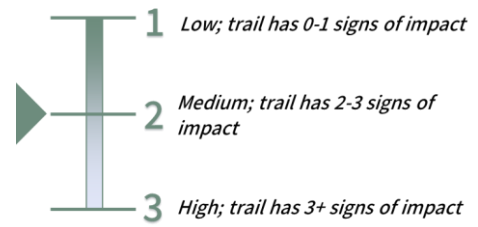
Figure 2. Trail condition and impact rating used during assessment.

Sections of trail that exhibited signs of needing new boardwalk infrastructure were categorized by trail surface type (packed dirt, rock stepping-stone, non-durable surface/mud, etc.) and evaluated for signs of impact (trail surface erosion, excessive muddiness, impact on surrounding vegetation, user-created side trails, etc.) The impact rating assigned to a trail site was based on the number of signs of impact present (Figure 2). Trail sites were also assessed for use level (light, moderate, or heavy traffic). As previously noted, this was a qualitative assessment based on perceptions during the assessment and inferred from the level of impact. User type was determined by observations on the site and clues from the area (bike tracks, dog prints, etc.). Length of impacted trail was measured for each site and as was user type (walker/runner, biker, dog walker). All noted boardwalk conditions and the site as a whole were photo documented. FBE assigned each site a photo number, from 1-01 to 2-64.

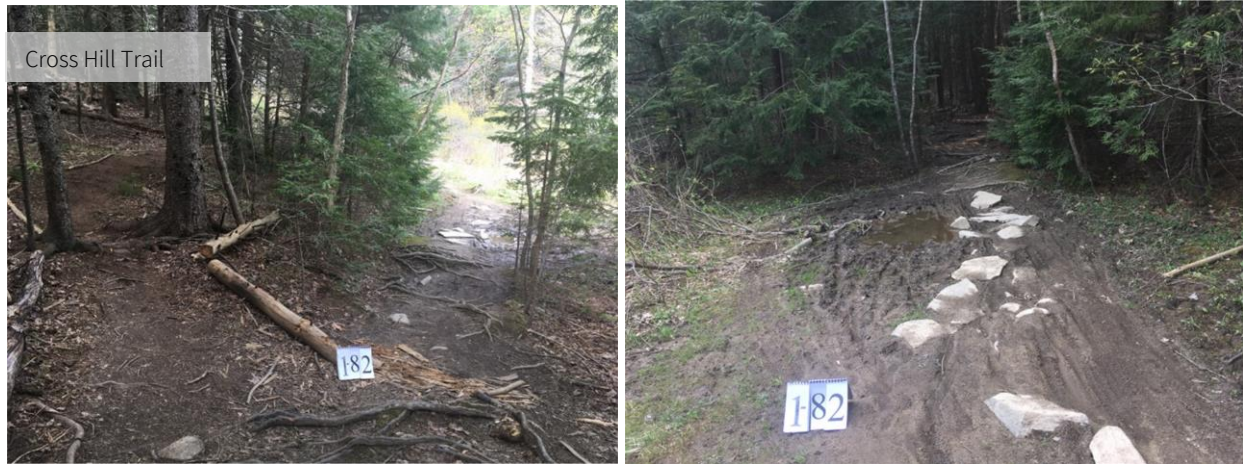
Photo 4. Example of a trail assessment site viewed from above (top) and below (bottom) with a recommendation to re-route the trail or install a new boardwalk. In this example, the re-route appears to already be partially established by trail users and could be fully established with confirmation of land access rights.

Trail site recommendations consist of new boardwalk installation or a trail re-route. Length, width, and height was specified for all recommended new boardwalks. If a re-route was suggested, the location and reason were detailed in site notes. Some sites may be improved by either method (Photo 4).

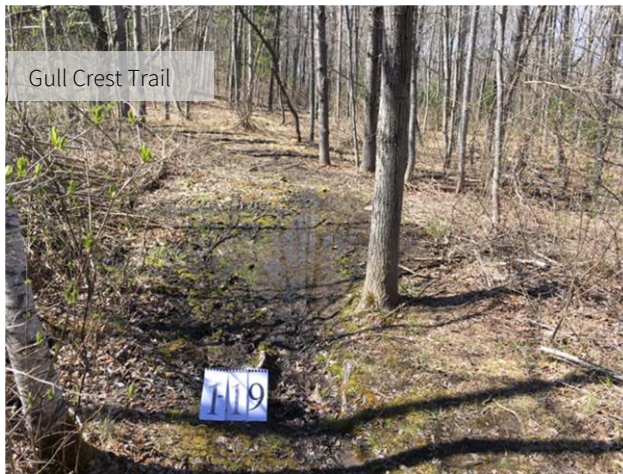
Photo 5. Low priority site due to excessive muddiness and standing water, likely due mostly to seasonal wetness.

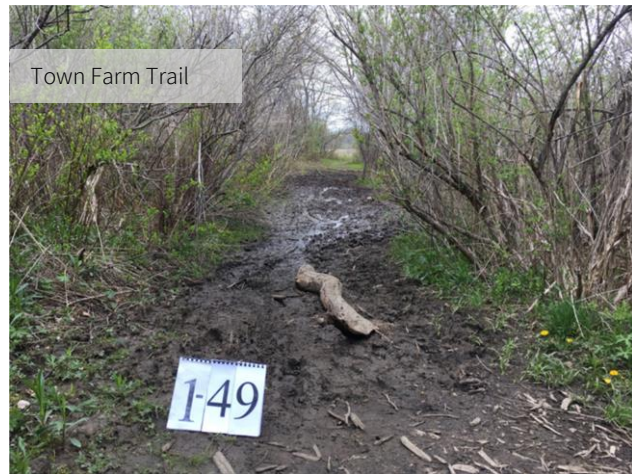
Photo 6. High priority site due to excessive muddiness, trail widening, and side trails negatively impacting surrounding vegetation.

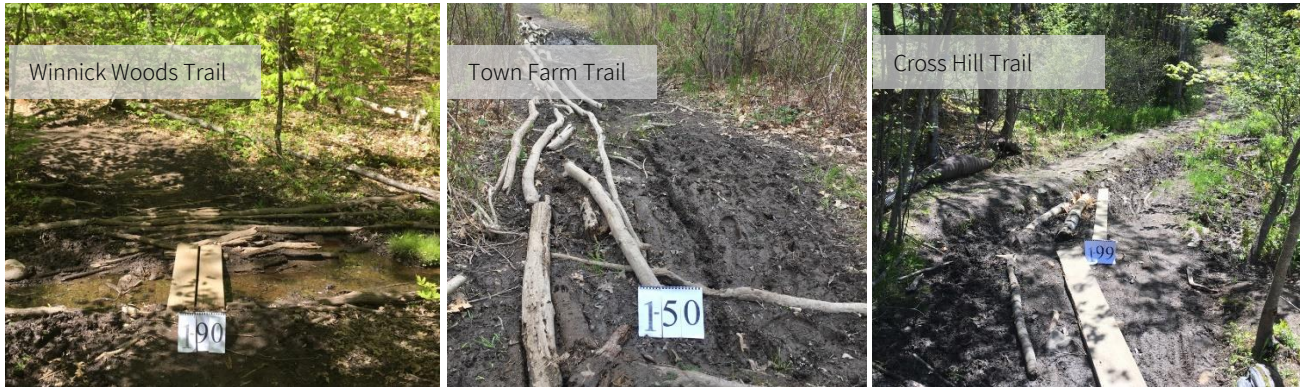
Sites that are in heavily trafficked areas tend to experience more physical wear, causing impacts to worsen, such as negative impact on vegetation due to side trails around an excessively muddy stretch of trail. Increasing the user satisfaction through a boardwalk installation, in this example, also curbs the impact on surrounding vegetation. Highly impacted, heavily trafficked sites are top priority for maintenance or additional boardwalk infrastructure, while low impact, lightly trafficked sites are lowest priority (Photo 7).

Photo 7. Three examples of top priority sites, rated as high impact, heavily trafficked.

- Repair existing greenbelt boardwalk infrastructure that are high impact and located on heavily trafficked trails. Begin with repairs to rectify safety hazards in the future, such as missing or rotting boardwalk slats or boardwalk instability.

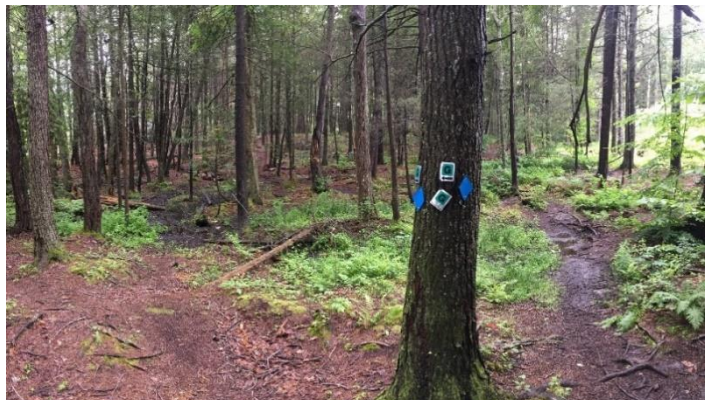
Photo 8. Cross Hill site 1-97 is an example of a site that was only partially within a mapped NWI wetland. FBE delineated this site to ensure accurate wetland lines within a 100-foot radius of the site.

partially within NWI wetlands. For this scenario, FBE delineated the wetlands to ensure that a 100-foot radius surrounding the site was accounted for (Photo 8).

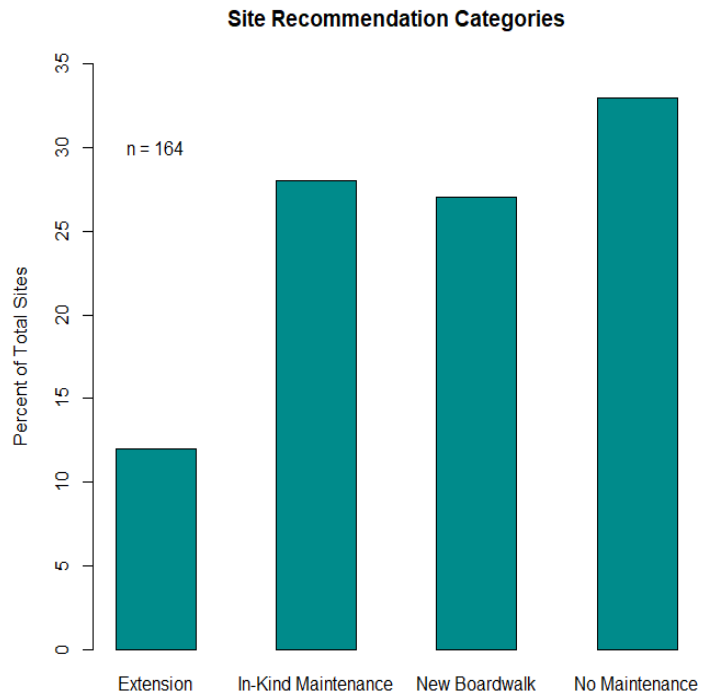
Figure 3. Recommended site maintenance categories as a percentage of total sites inventoried.

Of the existing boardwalk infrastructure sites, almost half do not require maintenance or updates and are in fully functional condition (Table 2). We recommend an extension for 19 of the boardwalk sites to improve their functionality and their usability while decreasing negative impact on the surrounding vegetation (note that 6 of these 19 also require some other maintenance, but for summary purposes in this report, they are categorized by extension). We recommend in-kind maintenance for 46 of the existing boardwalk infrastructure assessment sites. In-kind maintenance refers to repairs or improvements that do not expand the footprint of the boardwalk, and include recommendations such as replacing rotting decking, replacing rotting foundations or posts or installing foundations on boardwalks that currently lack stability, or replacing damaged or missing boardwalk slats. The most recommended maintenance action on existing boardwalks (in-kind maintenance) was replace boardwalk slats and replace boardwalk segments (Figure 4). We recommend a new boardwalk at 45 locations. All suggested repairs, extensions, and new boardwalk recommendations are quantified using the rating system devised for this project, measured, and photo documented in the assessment database.

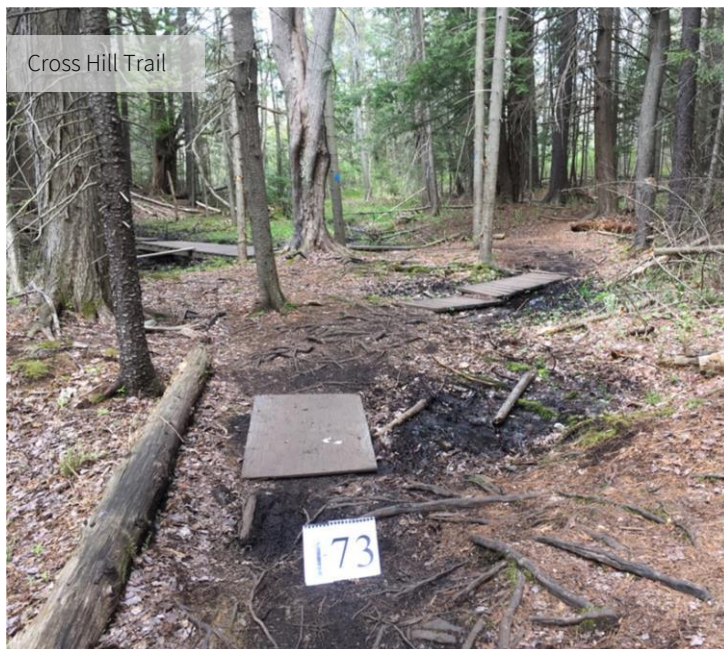
Seventeen high priority sites were identified for boardwalk assessment sites, and ten of these are rated as high impact on heavily trafficked trails (Table 4). All highest priority sites exhibited excessive muddiness and lacked complete boardwalk infrastructure; many lacked foundations (Photo 9). Note that Gull Crest 1-36 and 1-38 located on the outer loop of the Gull Crest Trail, were rated as high priority for repairs due to quantity/severity of rotting or missing boards (Photo 10). Gull Crest sites 1-34 – 1-38 were potentially fixed in May 2020 by scheduled repair work. At sites that are ranked as medium or low priority and experience muddiness or standing water, we recommend signage that requests bikers dismount while crossing wet areas. Deep bike ruts in muddy trail sections exacerbate existing problems and often encourage walkers and runners to seek alternate routes around the mud and create side trails.

Photo 9. Example of high priority boardwalks lacking foundations.

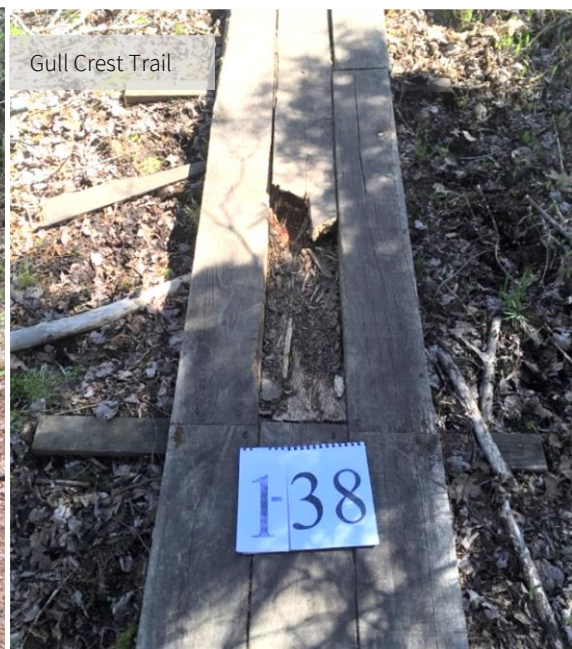
Photo 10. Example of high priority repairs. Site 1-38 requires more than ten repairs similar to this.

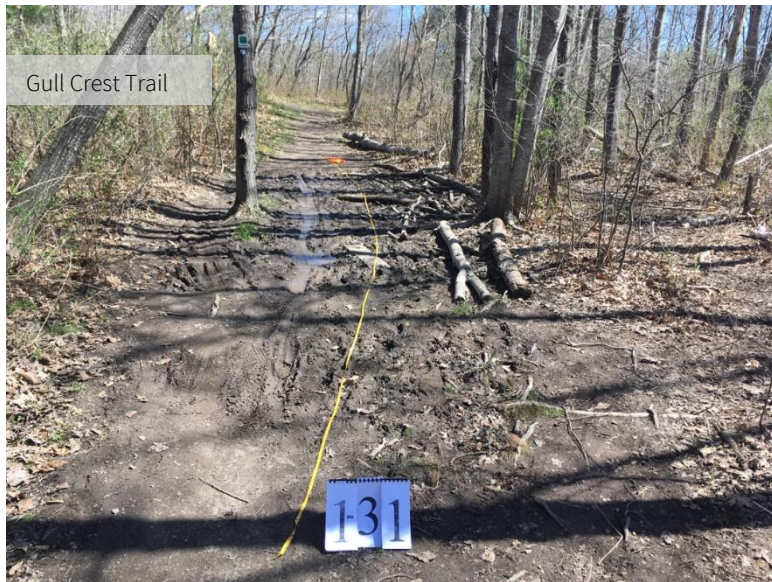
Nine high priority sites were identified for boardwalk assessment sites, and five of which are rated as high impact on heavily trafficked trails (Table 5). All highest priority sites exhibited excessive muddiness and multiple side trails that passed around the mud through the vegetation on either side of the trail (Photo 11). Many also had standing water in the trail at the time of assessment, exacerbated by deep bike ruts or footprints.

Photo 11. Example site of excessive mud with side trails going right and left around the site.

- Install new boardwalk infrastructure at high impact sites to protect the trail vegetation and increase user enjoyment. Start on trails that are heavily or moderately trafficked.

- At sites that consistently experience heavy traffic causing side trails on surrounding vegetation, consider posting educational signs about vegetation protection.

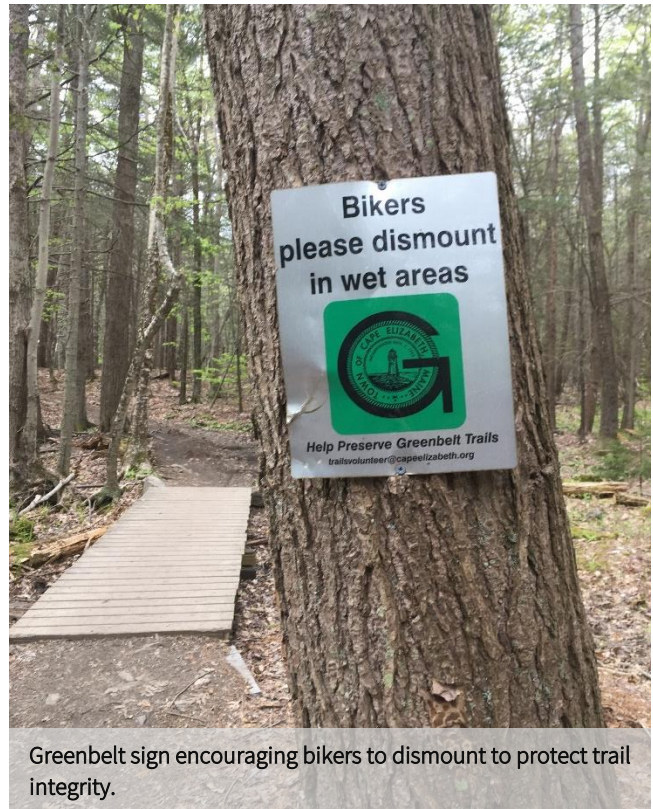
Greenbelt sign encouraging bikers to dismount to protect trail integrity.

- At medium or low impact sites that are not priorities, consider posting additional signs requesting bikers dismount while crossing wet areas. Deep bike ruts in muddy trail sections worsen existing problems and often encourage walkers and runners to seek alternate routes around the mud and create side trails.
