Read Avenue Outfalls Repair Project Project Review, Update and Recommendations

November 8, 2023

READ AVENUE
 CONSTRUCTION PLAN

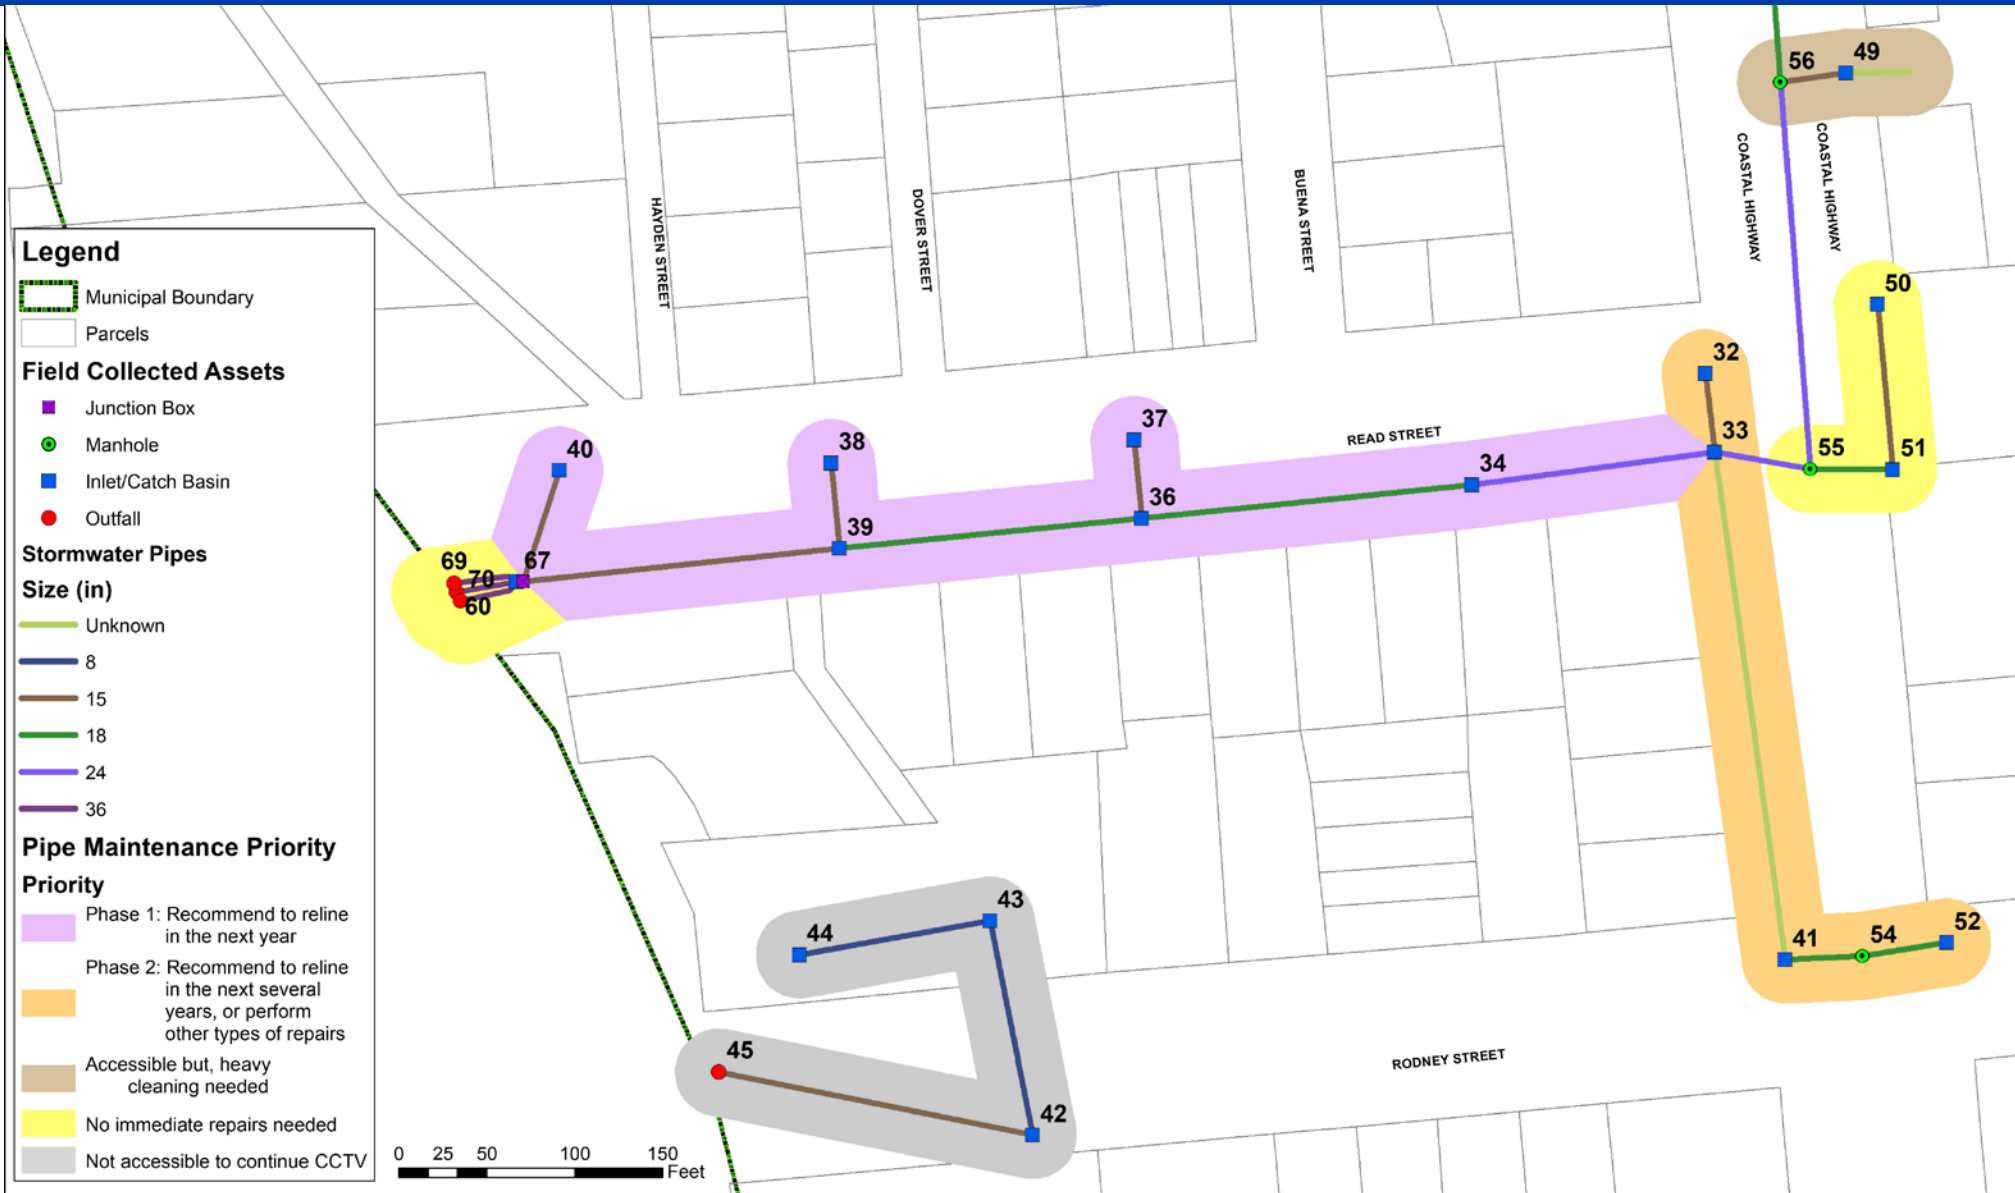
After some investigation, we firmly believe that the valves entering the bay are no longer working properly. This causes sand and water to wash into the pipes during high tide. It's verified that the pipes are partially under sand causing backups and flooding.

36" RCP (x3) – (Structures 67 to 60, 69, 70)

Note: Included heavy cleaning the line segments above due to the flooding from the pipes in the bay.

This work included excavating the sand below the invert of the pipes, removal of the three outfall valves, and the installation of a cofferdam around the three pipe locations. After the silt was removed, the area was stabilized before the installation of an underwater barrier using riprap R-5 or R-6 stone around the three pipes in order to protect the area from erosion. (See attached project area maps for reference).
