Crosswalks and Red Flashers

Delaware Department
of Transportation

HAWK Pedestrian Signal Compliance Review

May 2020

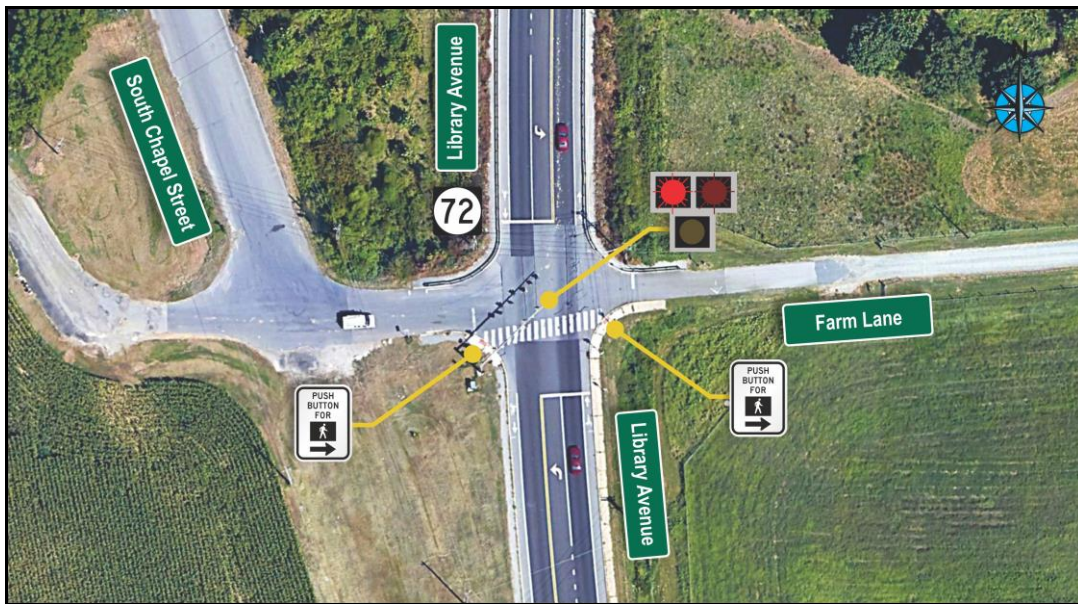
Figure 2: SR 72 and Farm Lane HAWK Signal

It should be noted that during the field observations completed by DeIDOT and RK&K, motorists from Farm Lane were frequently observed getting out of their car and activating the HAWK signal to stop traffic on SR 72. Once the HAWK signal activated, the motorists used the pedestrian phase to turn left onto SR 72.

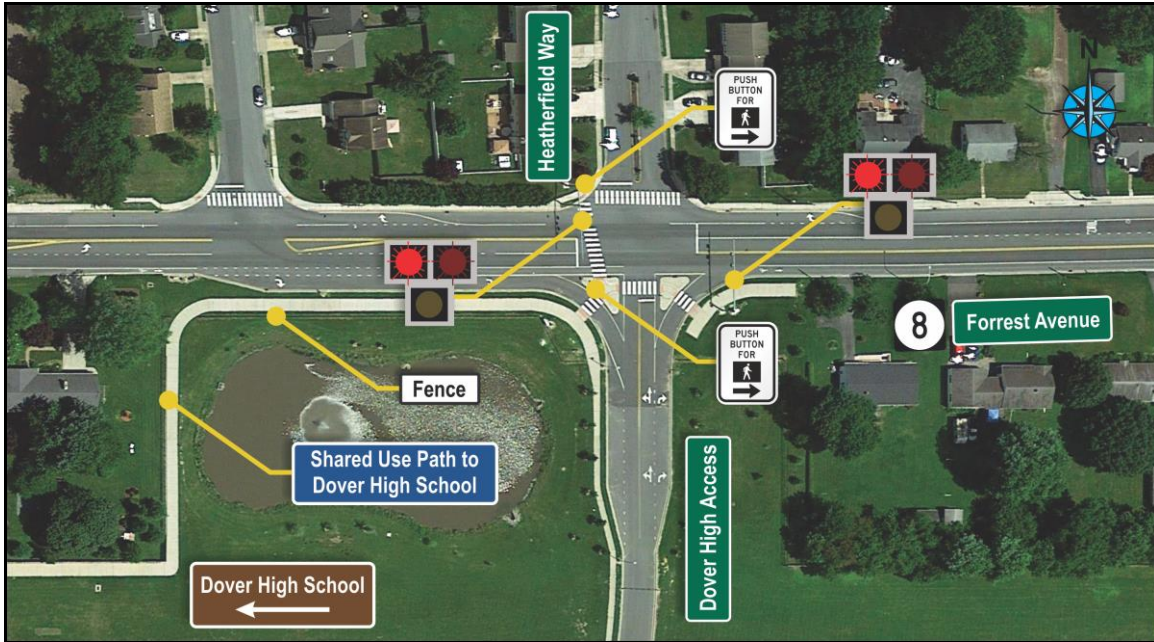
Figure 3: SR 8 and Heatherfield Way HAWK Signal

It should be noted that field observations revealed that motorists have learned that they can trigger the HAWK signal to turn left from the minor street approaches. Specifically, motorists from Heatherfield Way were observed getting out of their vehicles and activating the HAWK signal to stop traffic on SR 8. Once the HAWK signal activated, the motorists were more easily able to turn left onto SR 8.

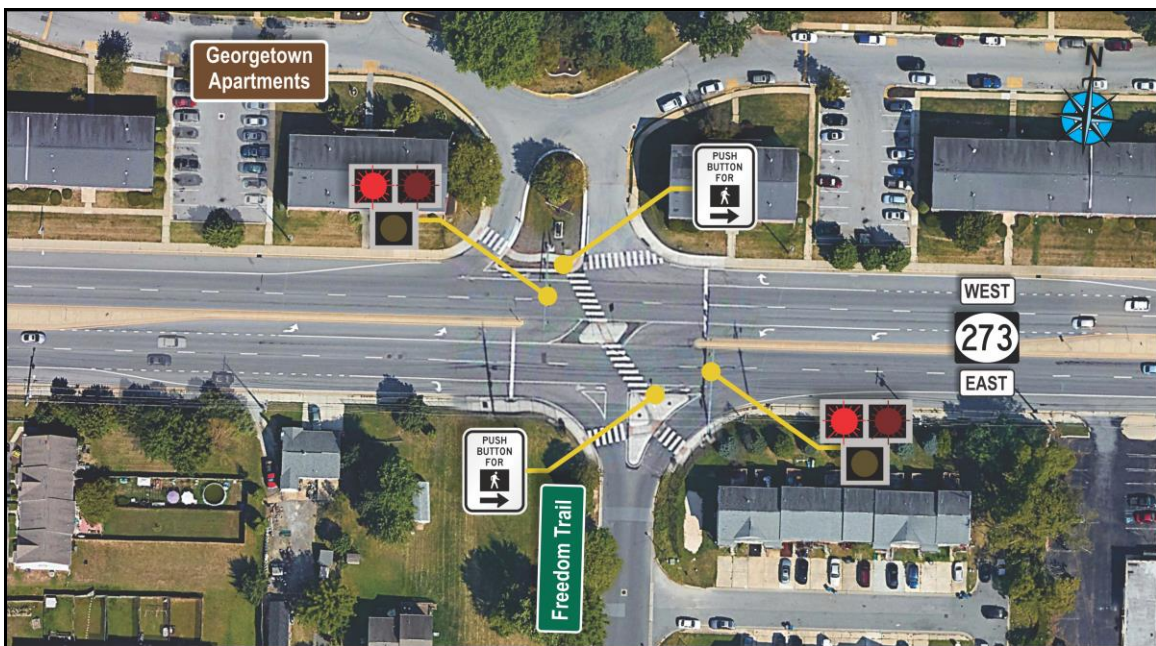
Figure 9: SR 273 and Farm Lane HAWK Signal

The HAWK signal on SR 273 at Freedom Trail is a single stage crossing. Pedestrians activate the HAWK signal and cross all of the lanes at one time. There is a pedestrian refuge island between the eastbound and westbound lanes on SR 273. However, there are no supplementary pedestrian signal push buttons in the pedestrian refuge island.
